# Fiber Reinforced Concrete and Deck Slab Cracking

Nishant Saini<sup>1</sup> and Mr. Abhishek Sharma<sup>2</sup>

<sup>1</sup>M. Tech. Scholar, Department of Civil Engineering, CBSGOI, Jhajjar, Haryana, India  
<sup>2</sup>Assistant Professor, Department of Civil Engineering, CBSGOI, Jhajjar, Haryana, India

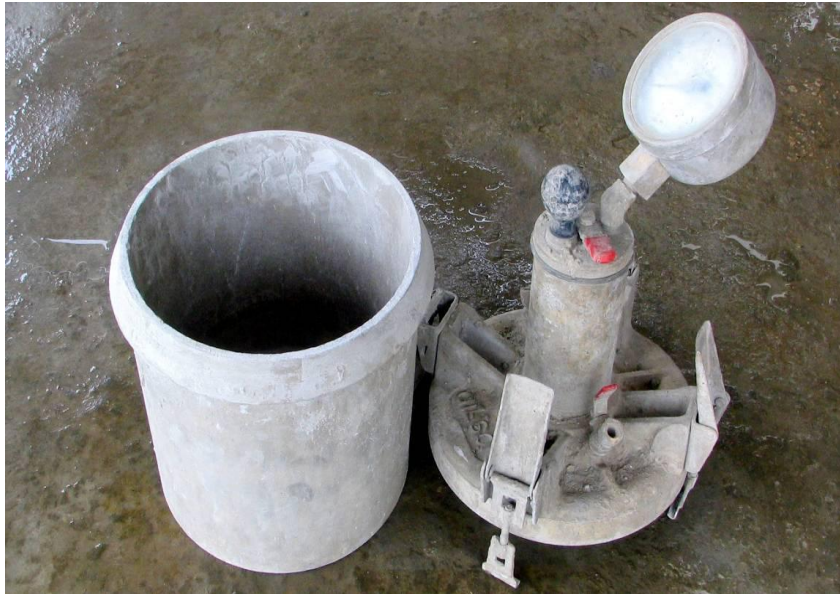
**Figure 1: Air Content Pressurized Air Pot Apparatus**

Several environmental conditions were measured at the time of batching, in addition to several fresh concrete tests being run. The air temperature and humidity were tested with a combined thermometer/hygrometer device. The concrete temperature was measured with a probe thermometer. The unit weight and air content of the mixes were measured with a pressurized air pot. The pot was weighed, filled with concrete, and weighed again. Using this data, and the fact that the pot was 0.25 cubic feet in volume, the unit weight was measured. The air content was measured according to ASTM C231. Figure 5.1 shows the air content pot apparatus. The slump test was carried out according to ASTM C143. Figure 5.2 shows the slump cone apparatus in use, before finishing.

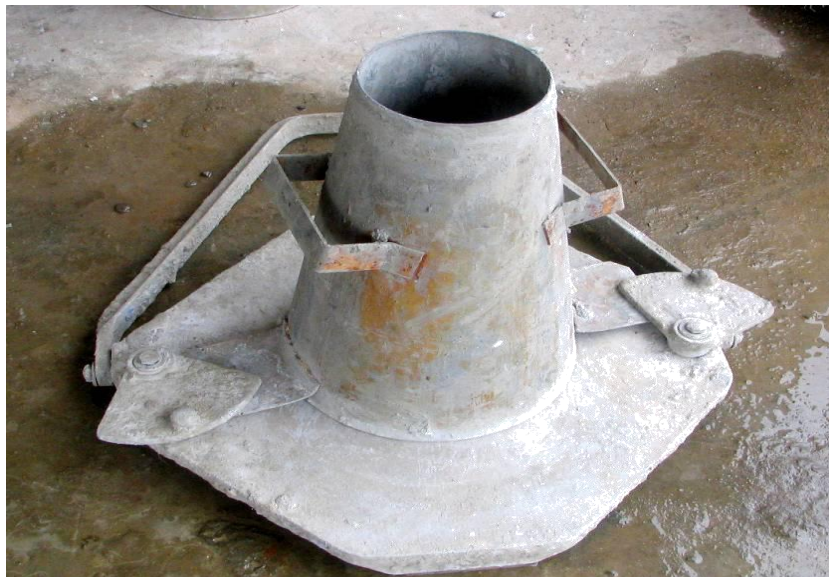
**Figure 2: Slum Test Apparatus**
